**ON-SITE AIR BAG INVESTIGATION**

CASE NO. - 96-05  
FLEET - PRIVATE VEHICLE  
LOCATION -  
ACCIDENT DATE - 1996

Case Vehicle: 1995 Volkswagen Golf III City, Five-door Hatchback

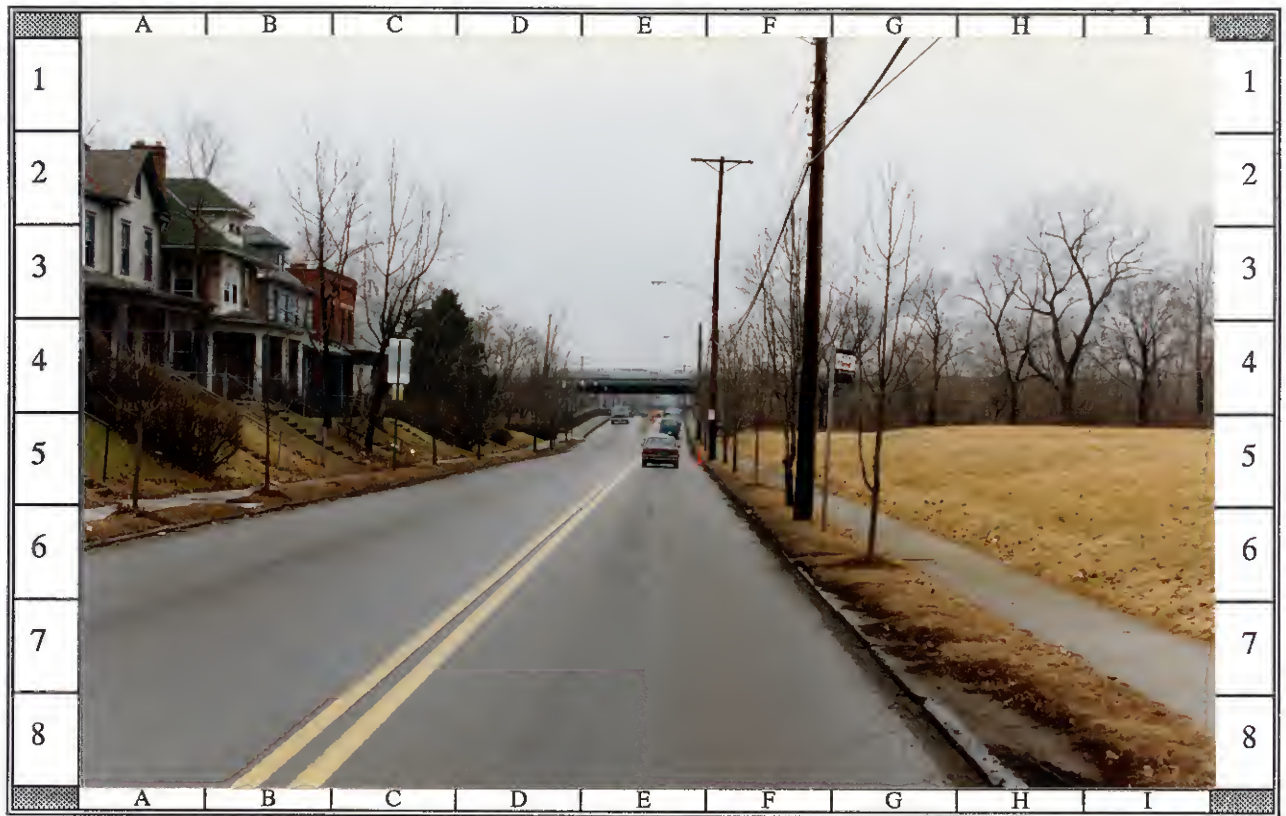
# 01: Case Vehicle’s westward travel path in westbound lane approximately 50 meters (164 feet) east of impact with utility pole (i.e., @ red cone)

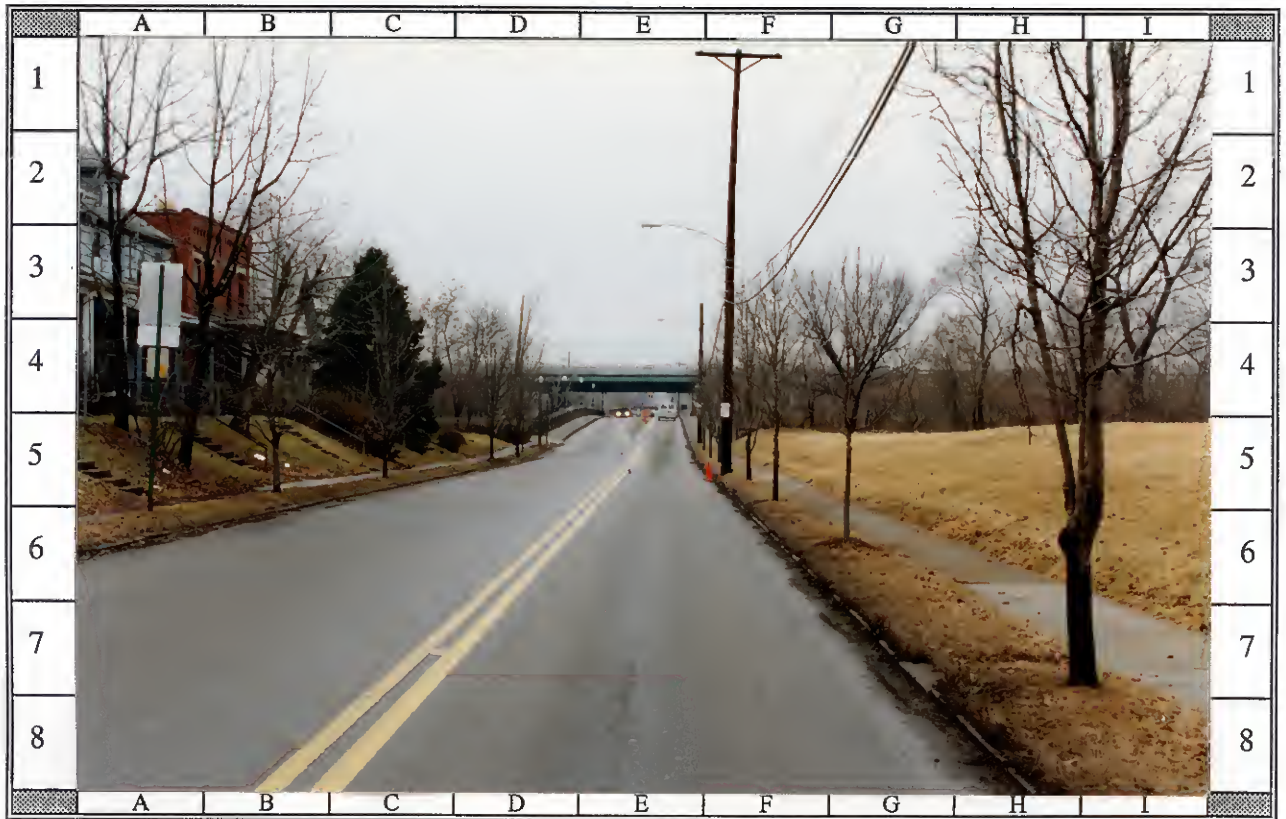
# 02: Case Vehicle’s westward travel path in westbound lane approximately 30 meters (98 feet) east of impact with utility pole (i.e., @ red cone)

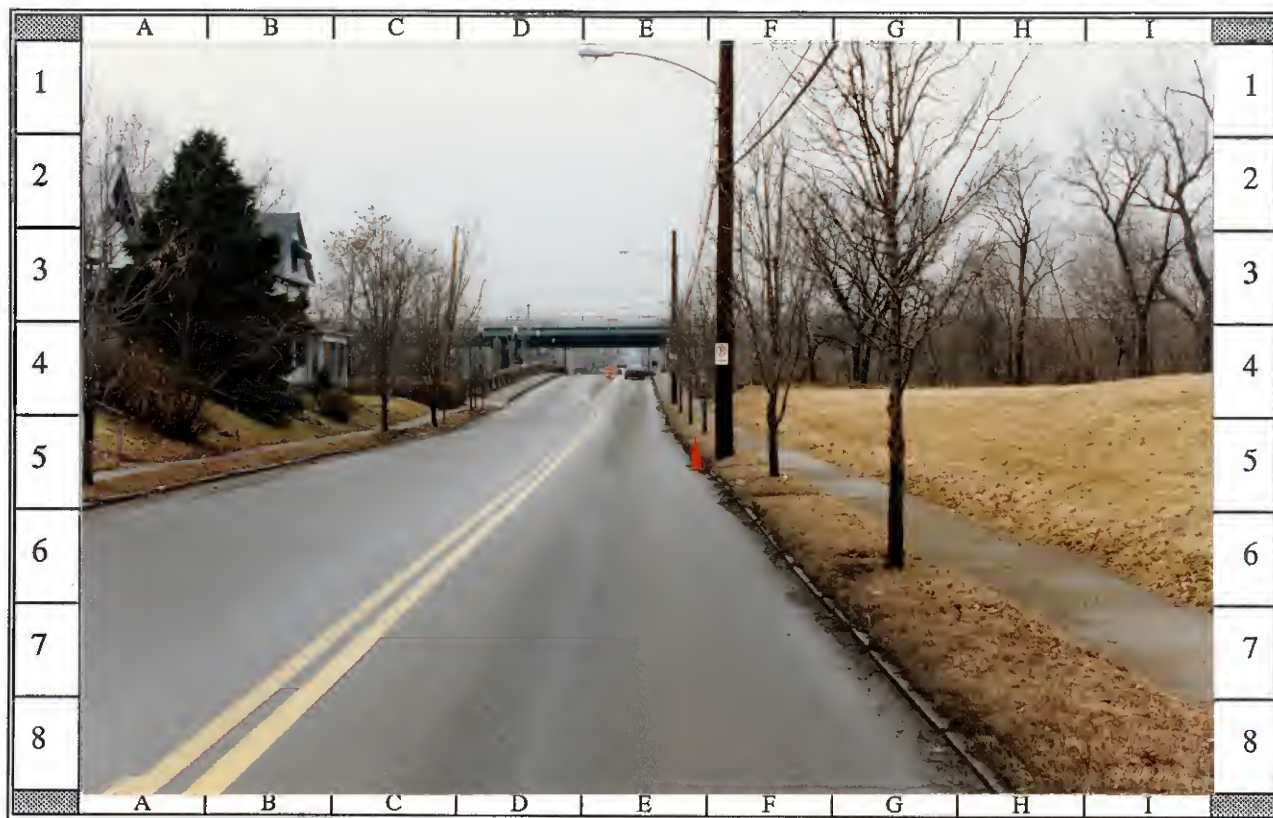
# 03: Case Vehicle's westward travel path in westbound lane approximately 20 meters (66 feet) east of impact with utility pole

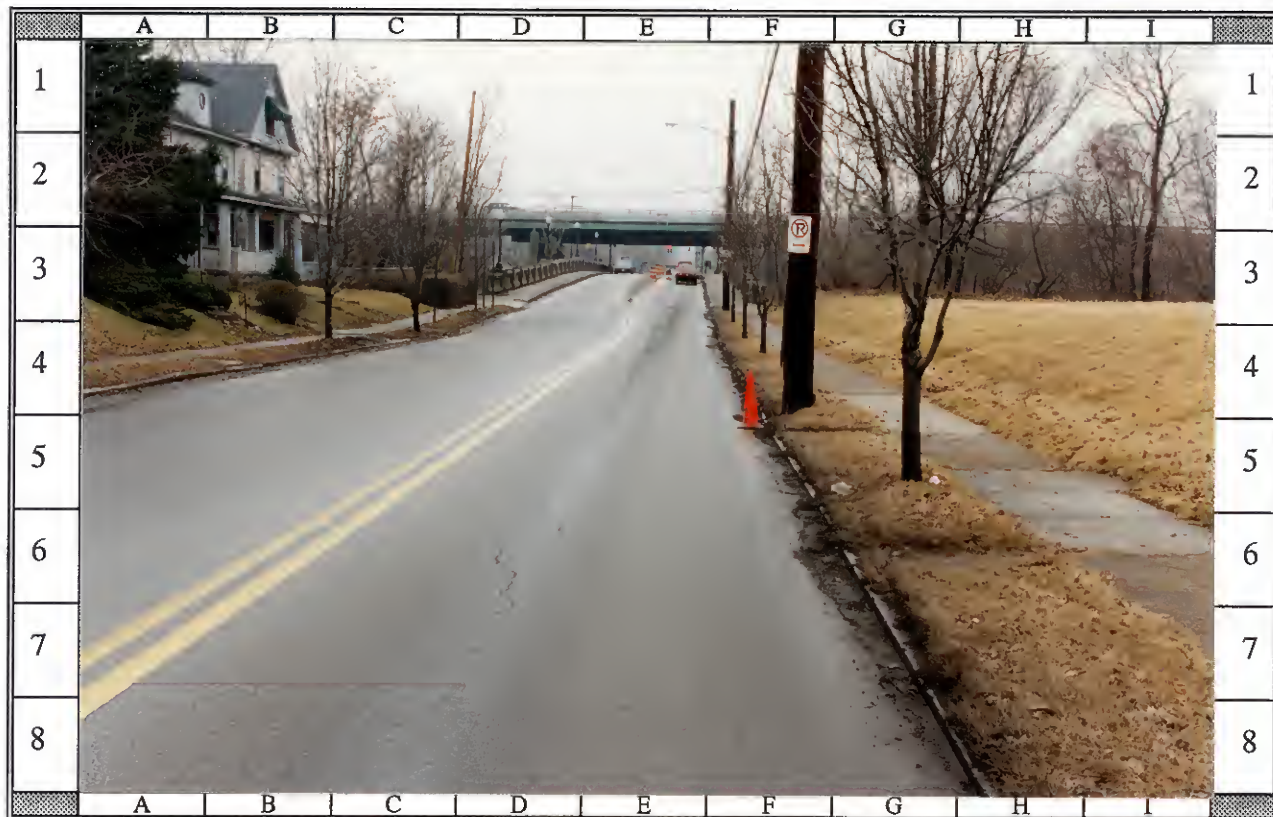
# 04: Case Vehicle's right front tire departs its westward travel path in westbound lane onto roadside approximately 13 meters (43 feet) east of pole impact

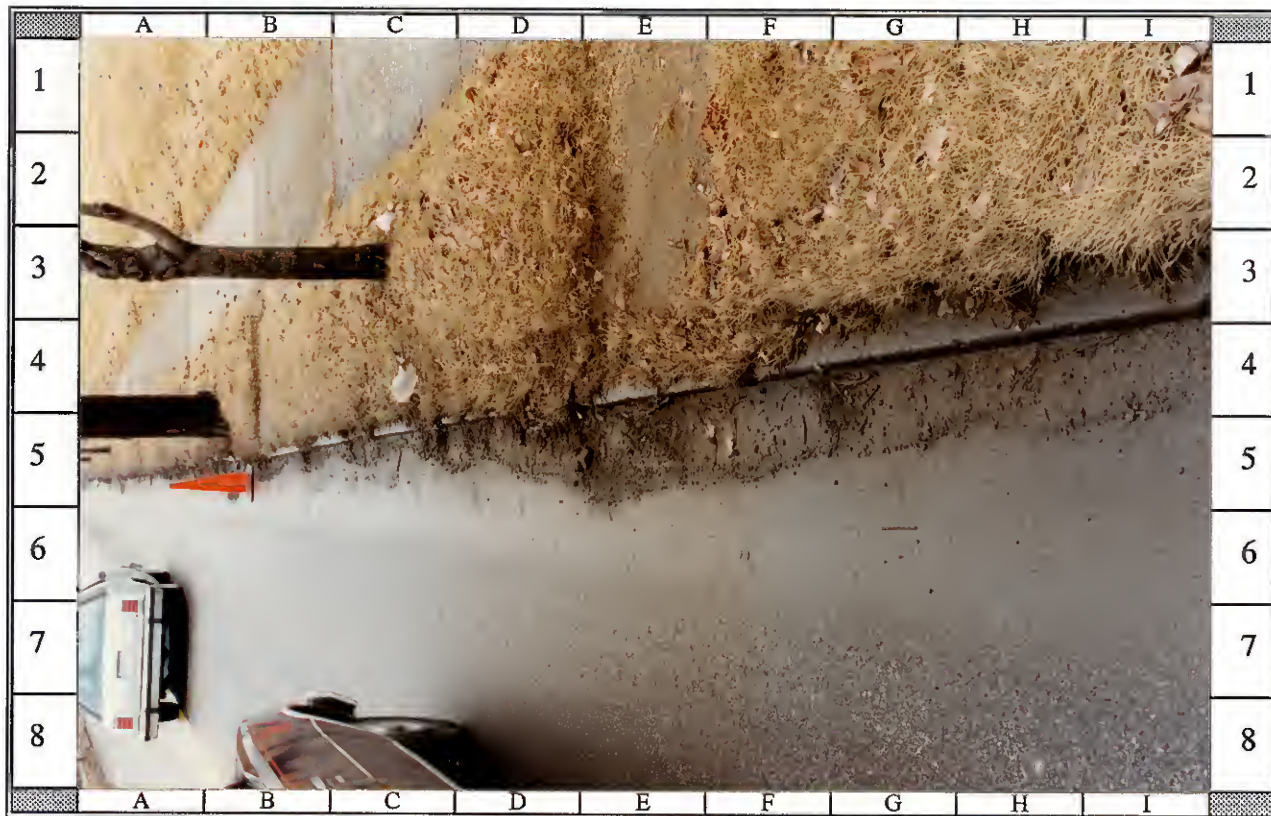
# 05: Westward view of Case Vehicle's right front tire imprint along north roadside after departing north edge of westbound lane (cell H3)

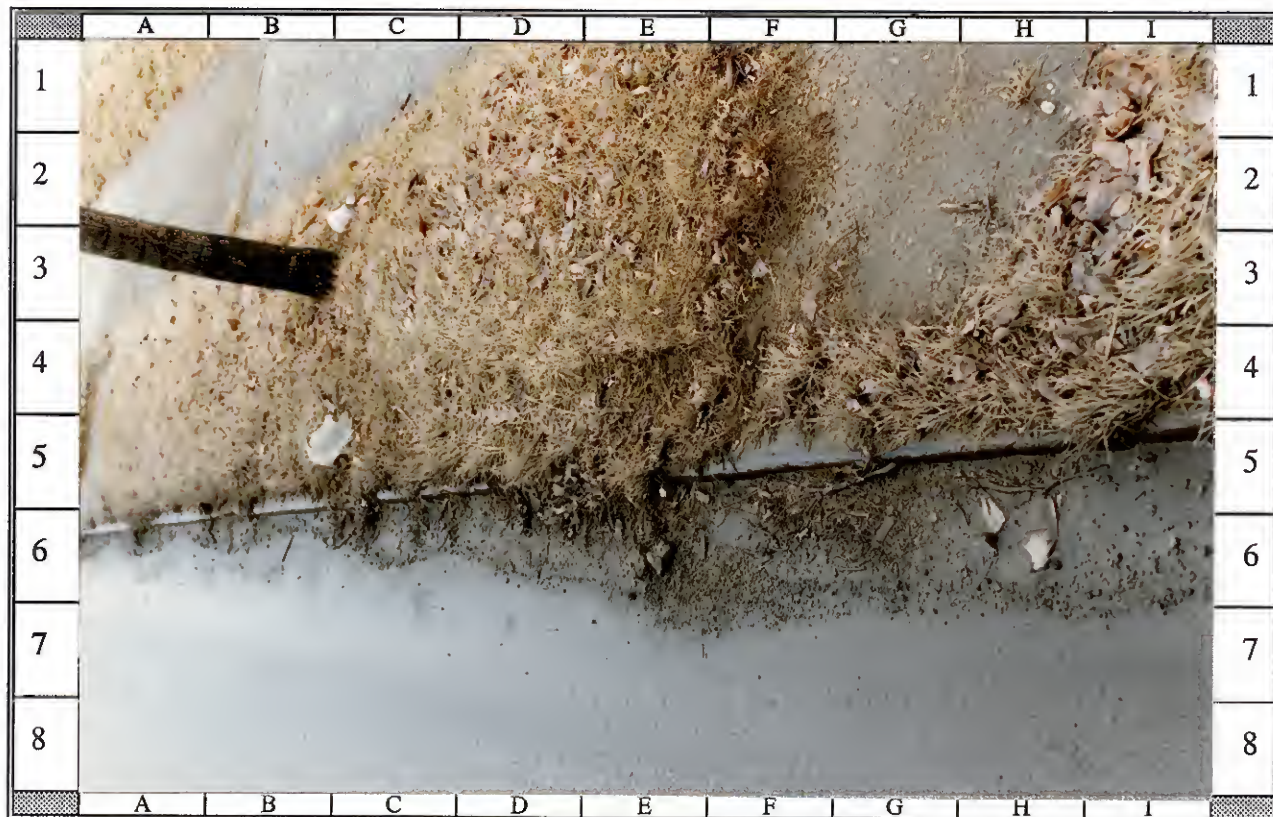
# 06: Close-up of Case Vehicle's right front tire imprint along north roadside grass approximately 10 meters (33 feet) east of impact with utility pole

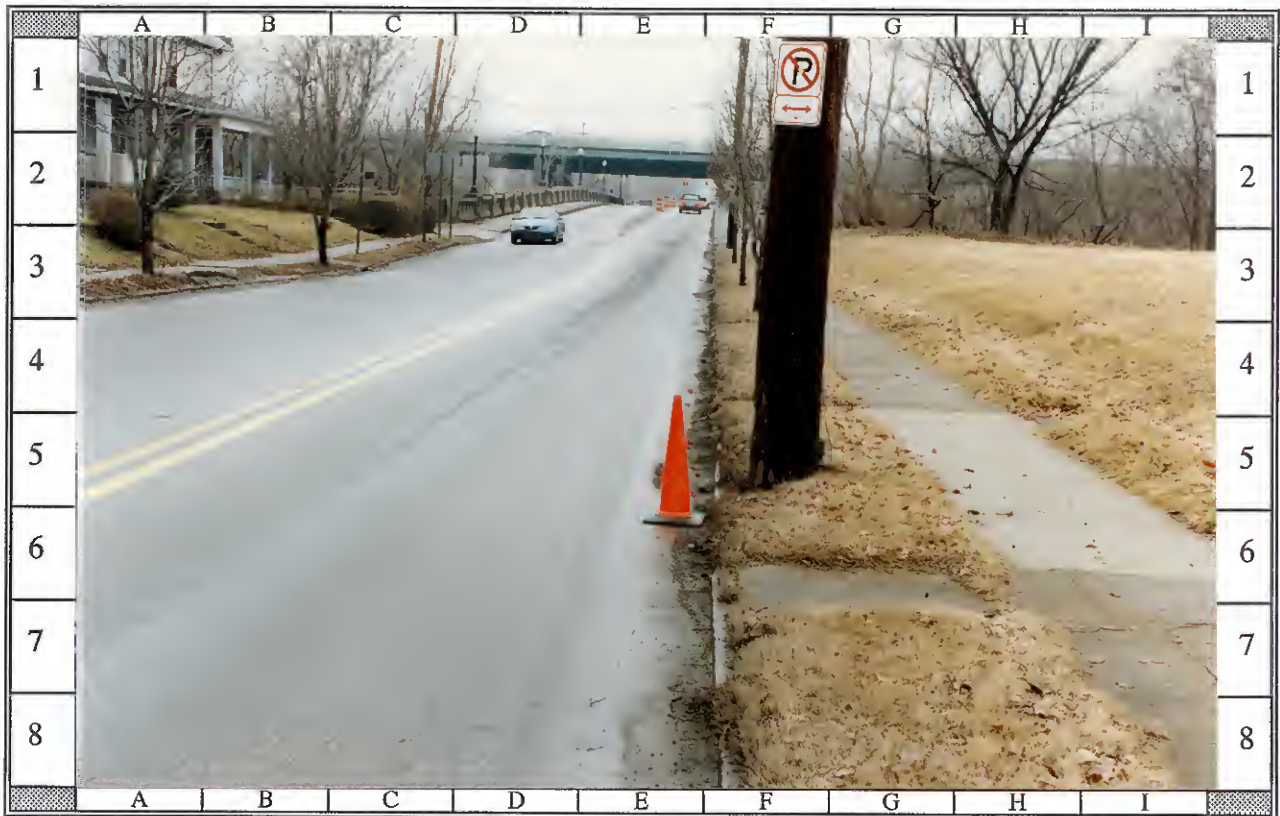
# 07: Case Vehicle's westward travel path while partially on north roadside approximately 5 meters (16 feet) east of impact with utility pole

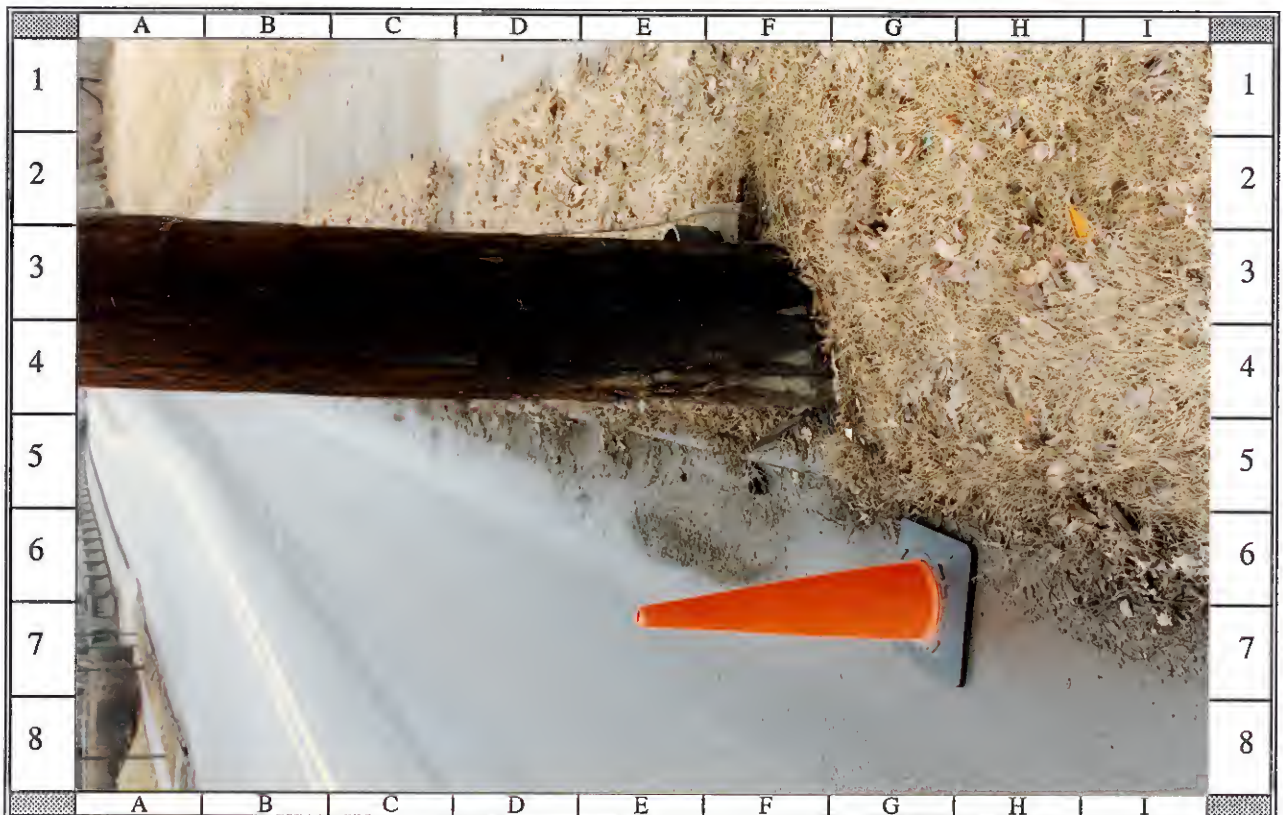
# 08: Close-up of Case Vehicle's right front tire imprint along north roadside leading into struck utility pole; NOTE: broken turn signal glass (cell I2)

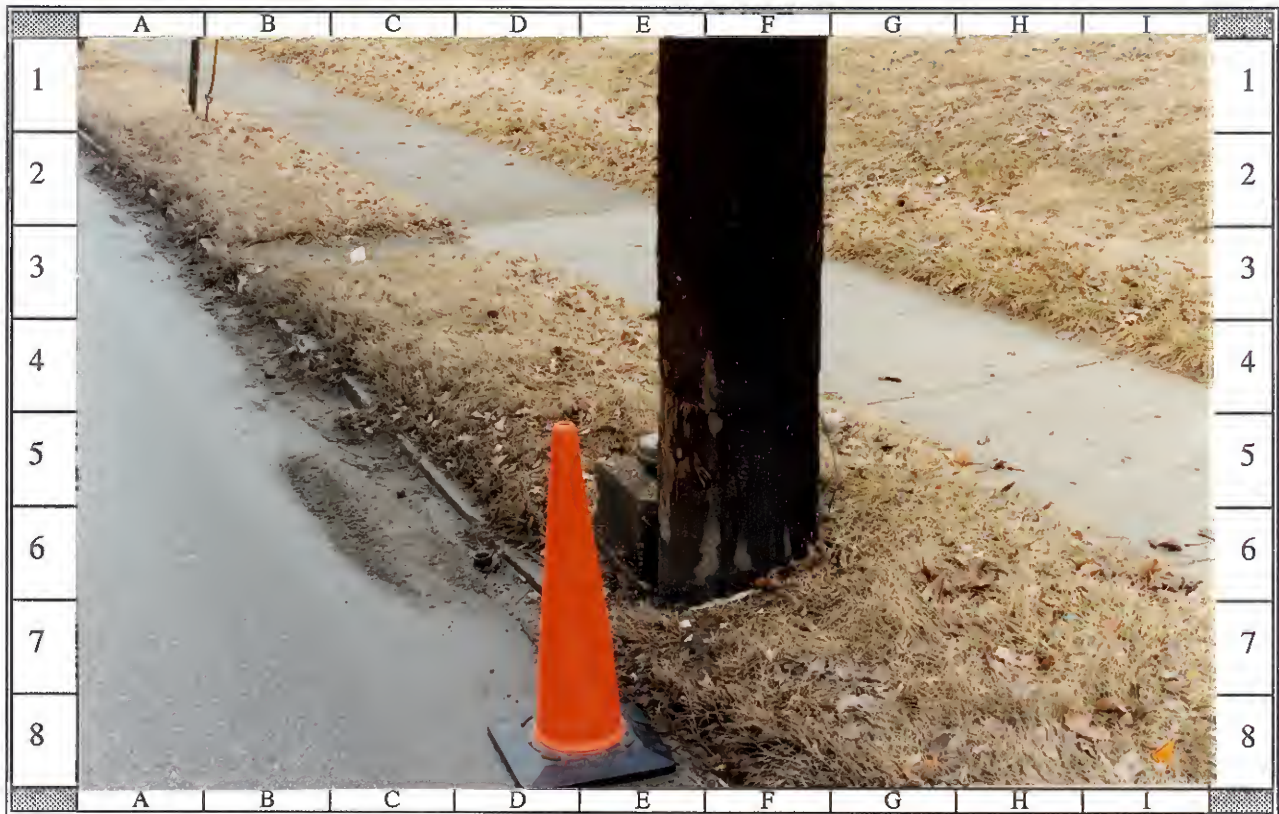
# 09: Northwestward close-up view of damage to southern base of utility pole caused by impact with Case Vehicle's front right bumper and right fender

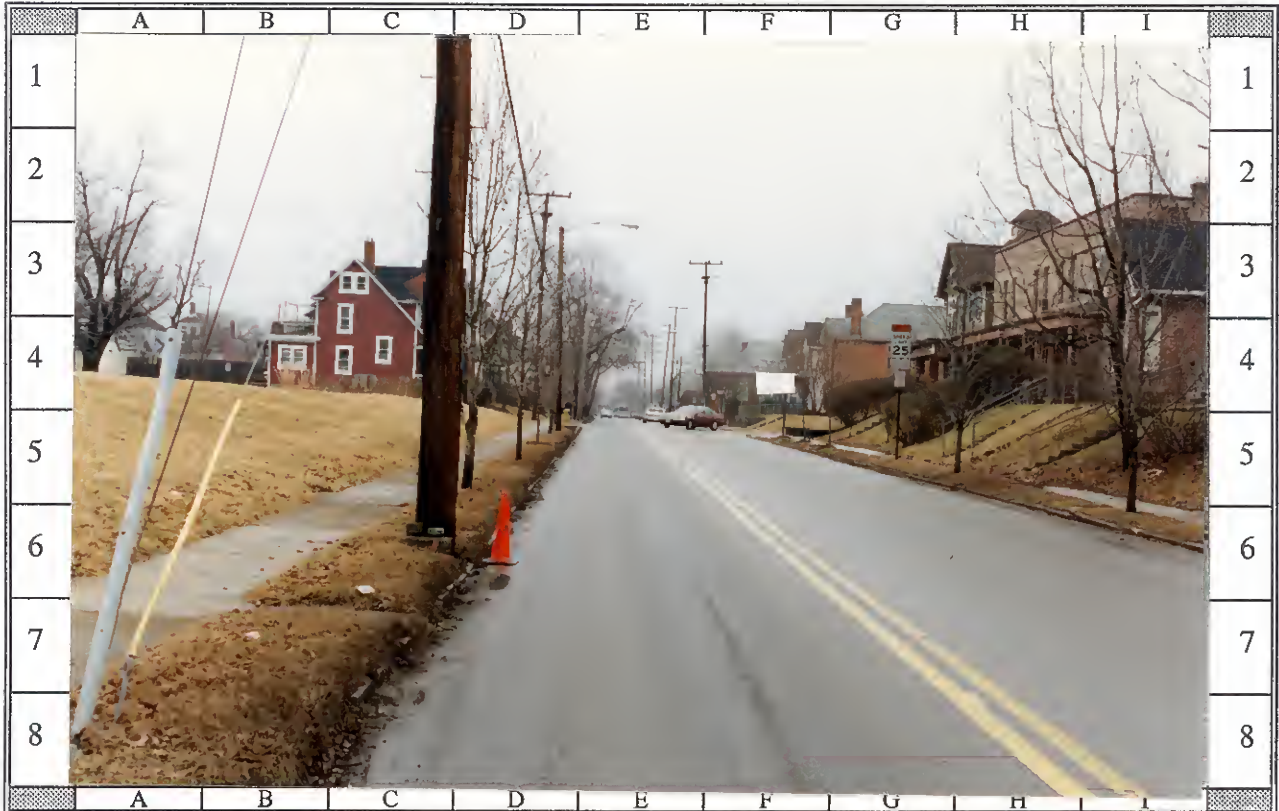
# 10: Eastward view of Case Vehicle's westward travel path leading into utility pole (red cone) from approximate area of final rest

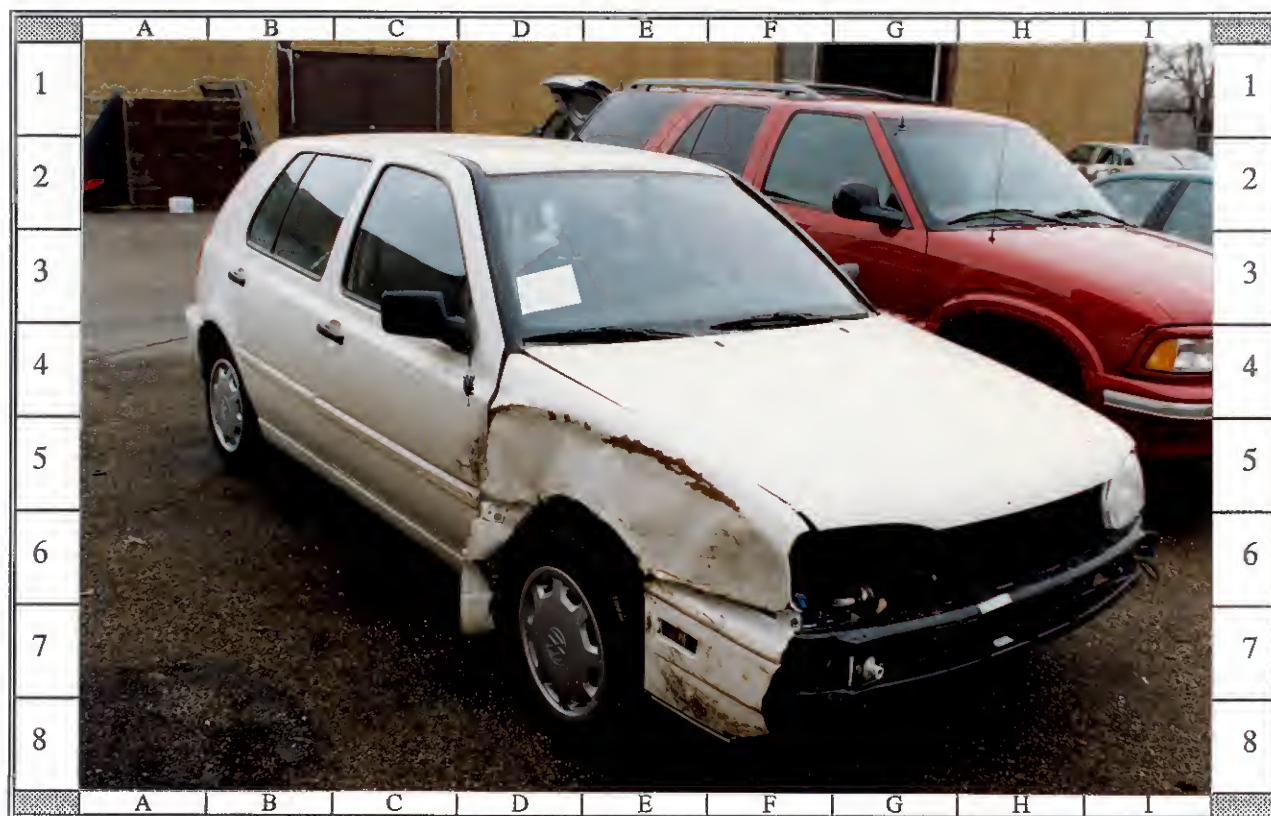
# 11: Case Vehicle's damaged front right bumper and right front fender viewed from ~ 45 degrees right of front; NOTE: vehicle in process of being repaired

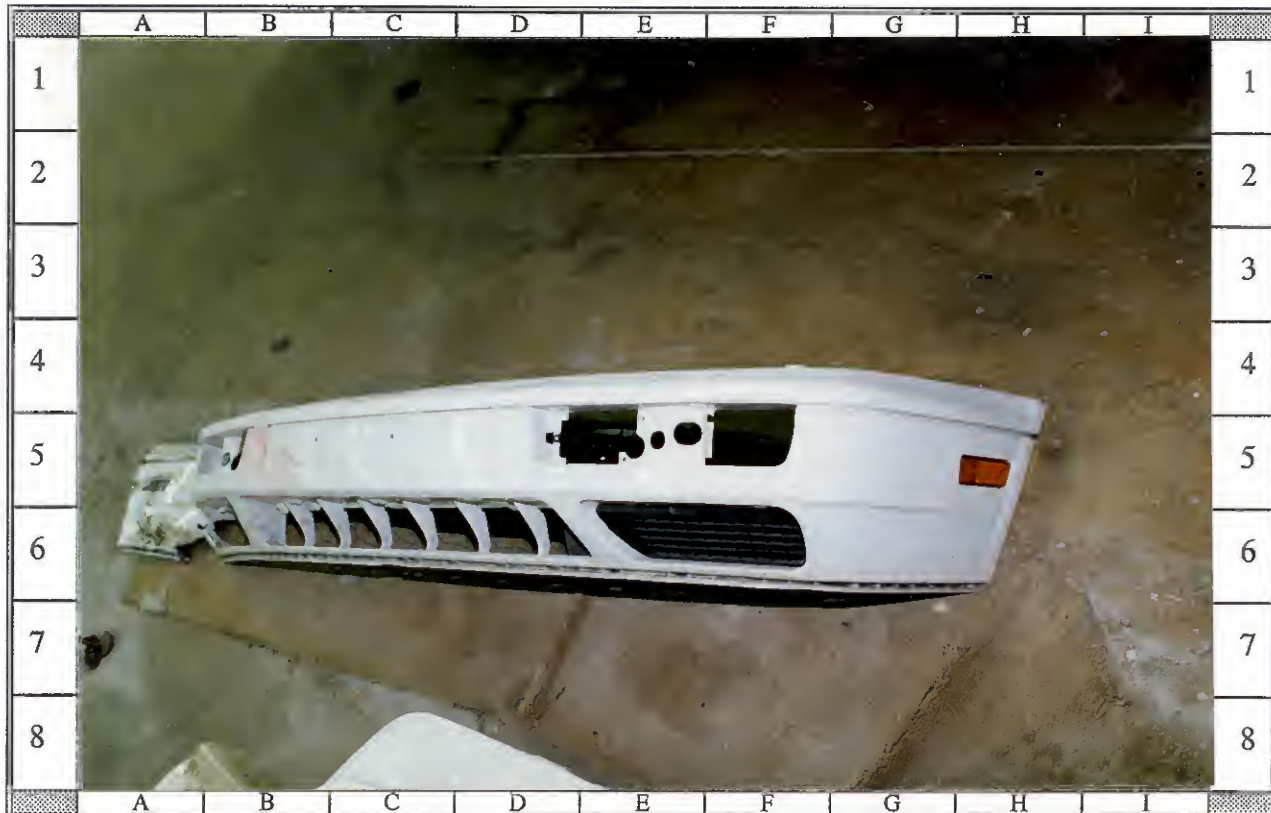
# 12: Case Vehicle's damaged front bumper fascia, viewed from left, which was removed during repair process; NOTE: direct damage to front right corner only

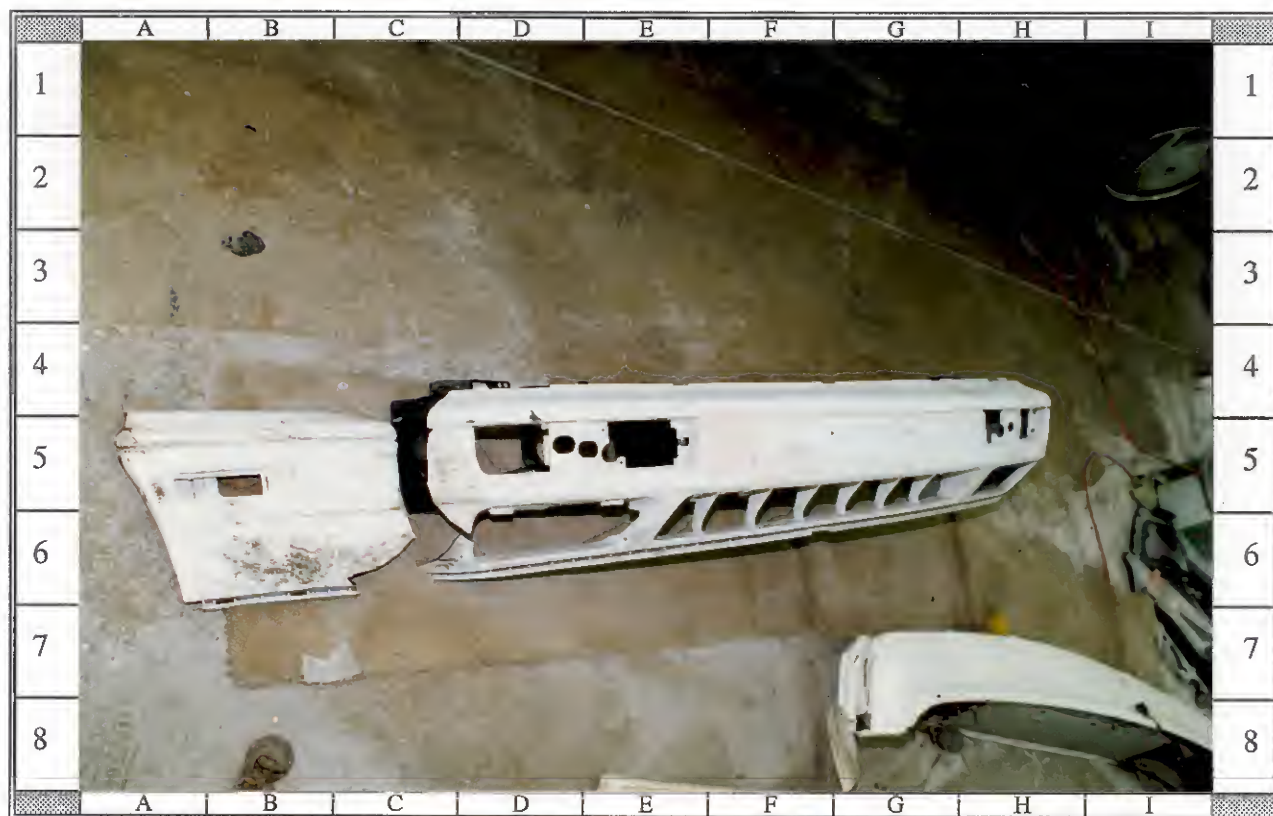
# 13: Rightward view of Case Vehicle's damaged front bumper facia which is on top of reinforcement bar; NOTE: direct damage to front right corner only

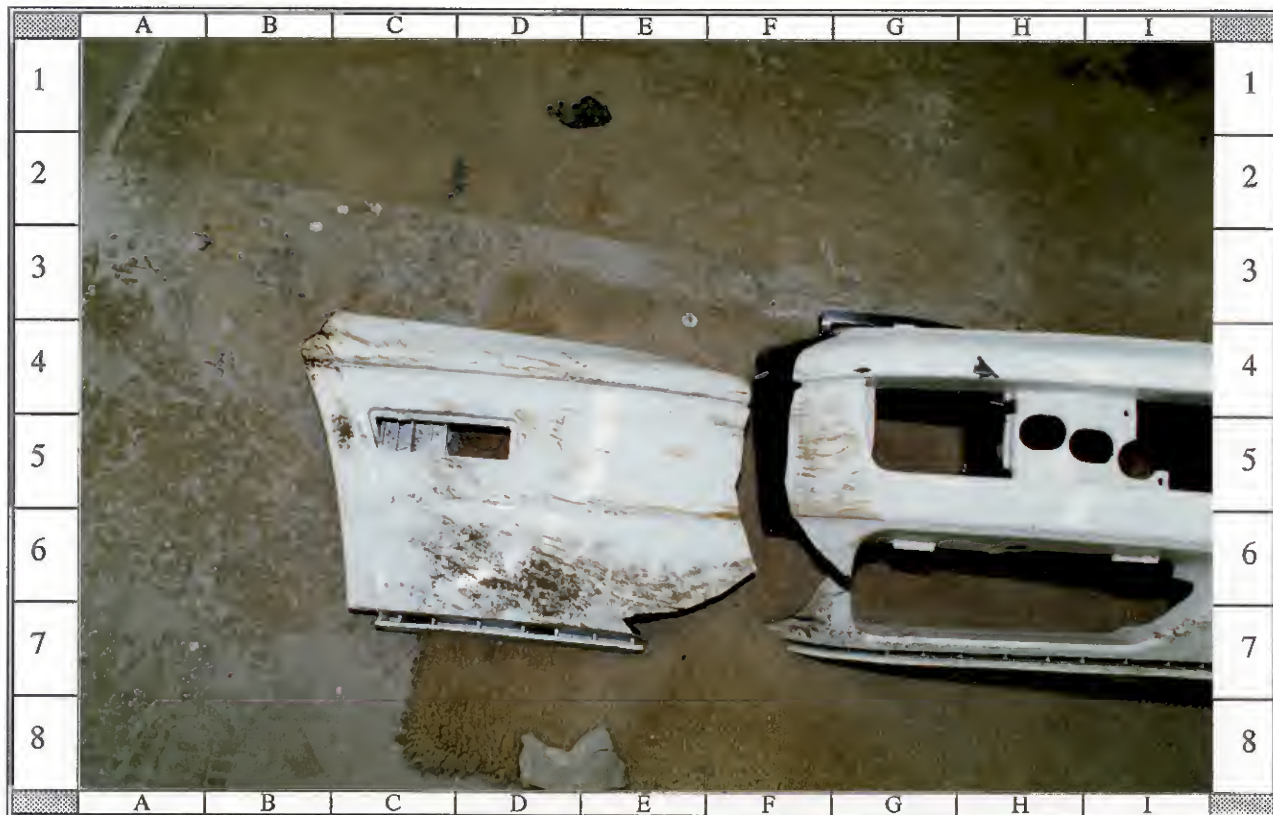
# 14: Close-up of damaged right corner of Case Vehicle's front bumper facia; NOTE: direct damage extends just leftward of right bumper corner

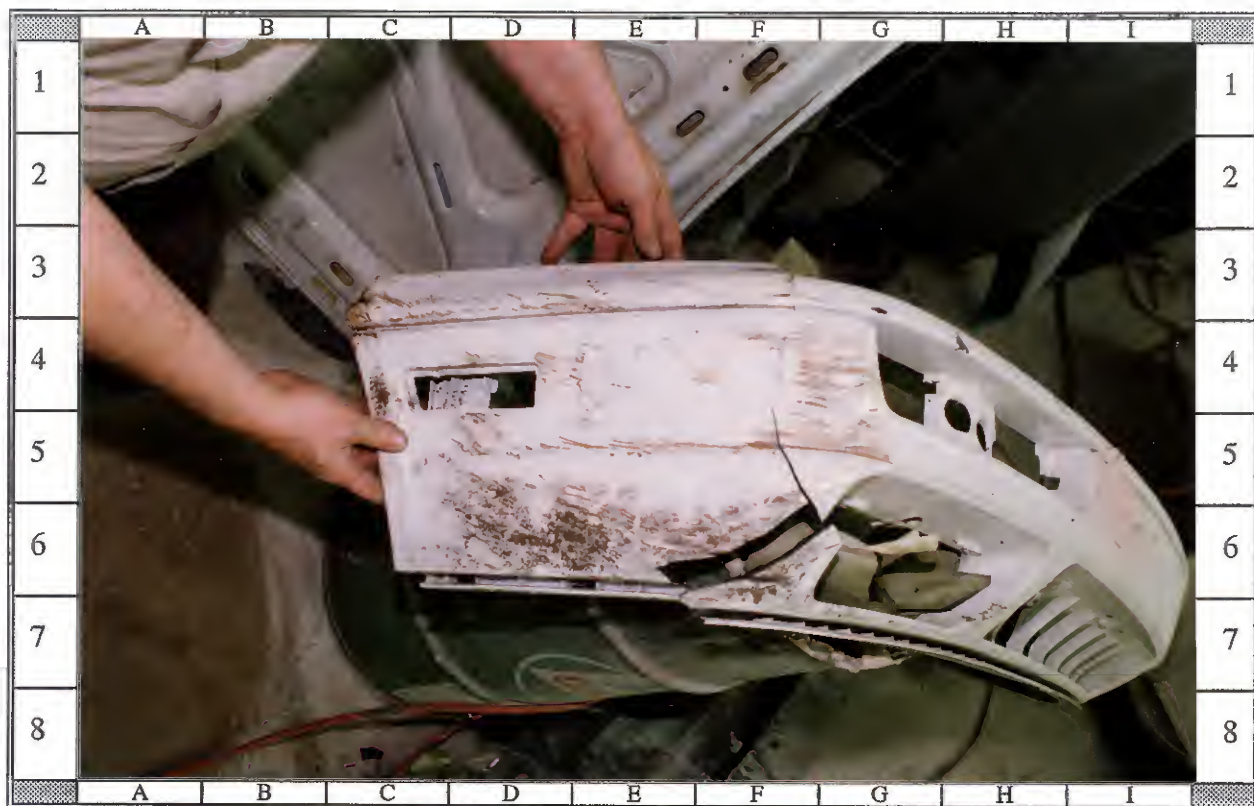
# 15: Case Vehicle's front bumper fascia showing two pieces of damaged front right corner as they were originally formed prior to the crash

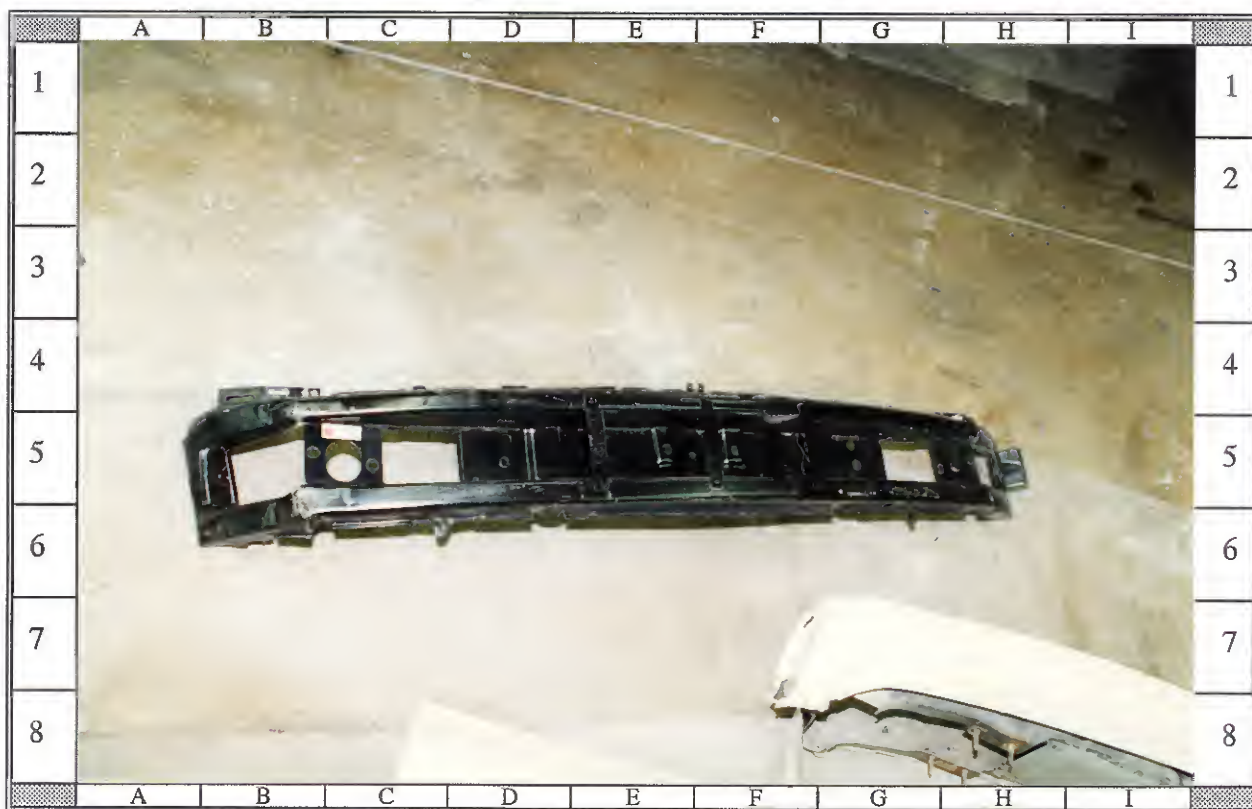
# 16: Case Vehicle's removed bumper reinforcement; NOTE: direct damage extends to right end of white tape (cell C5)

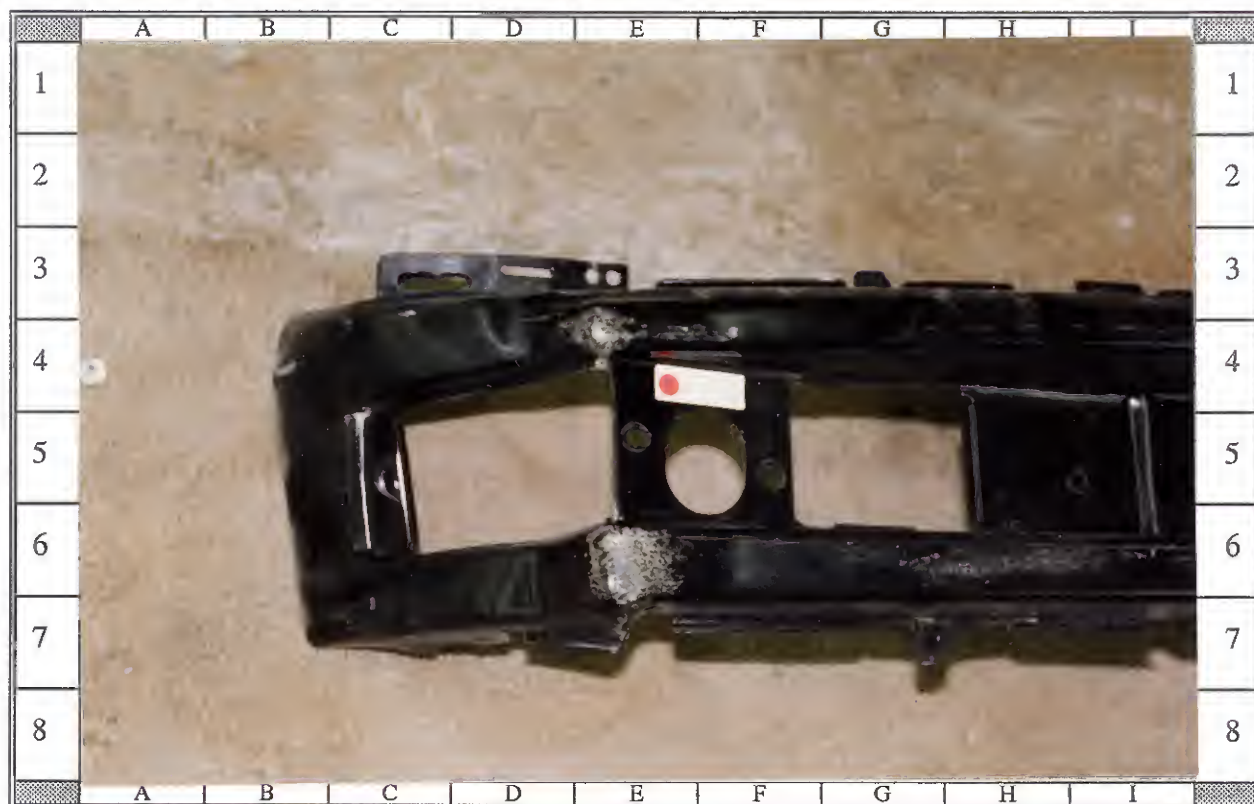
# 17: Close-up of Case Vehicle's removed bumper reinforcement; NOTE: direct damage measures 5 centimeters (2 inches) from bumper crease

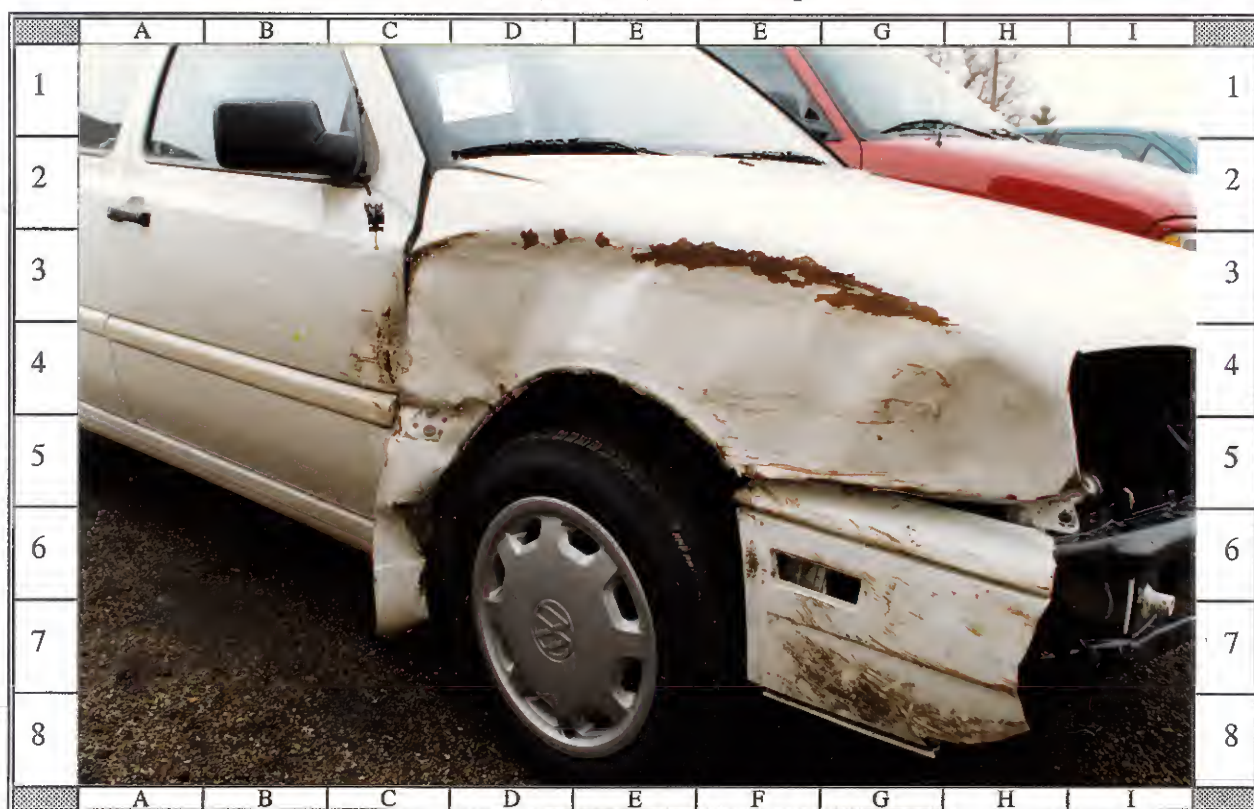
# 18: Case Vehicle's damaged right front fender viewed from approximately 60 degrees right of front; NOTE: right front wheel assembly already repaired

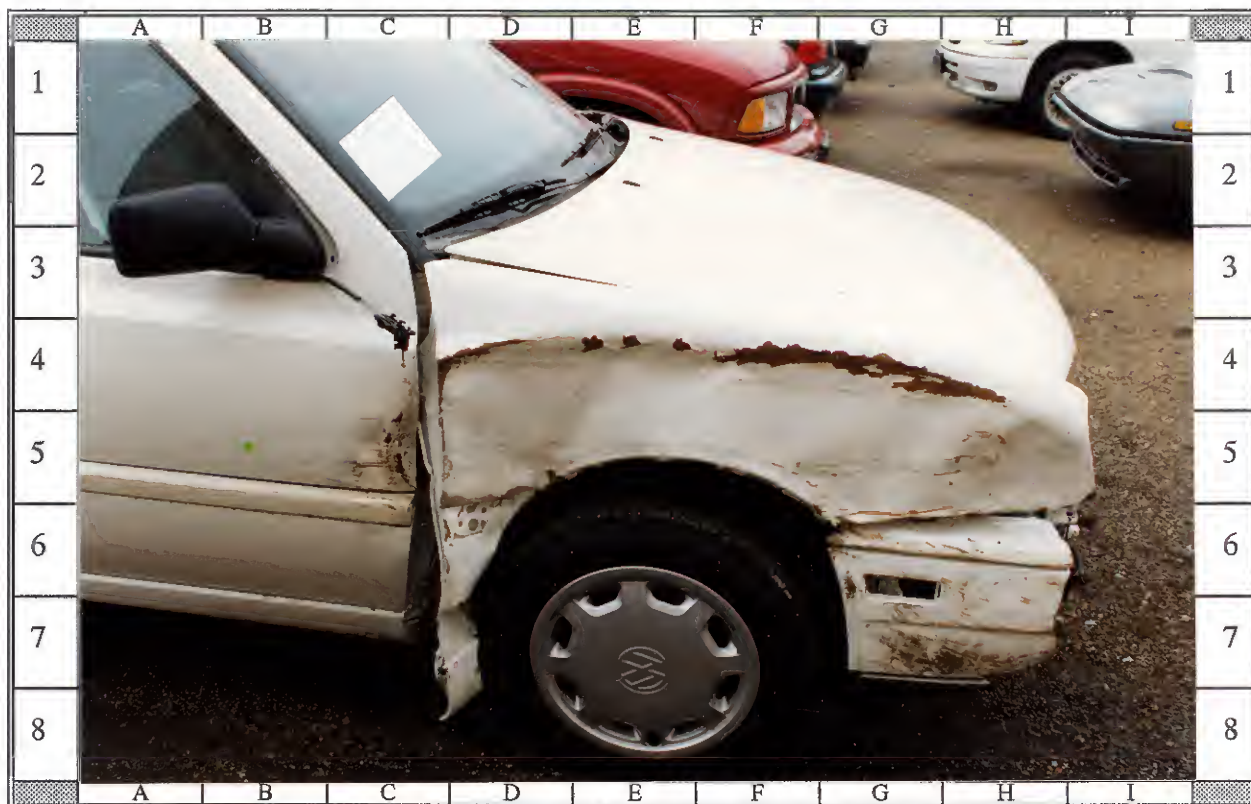
# 19: Case Vehicle's right front fender showing area of direct damage viewed from right; NOTE: direct damage extends rearward to green dot (cell B5)

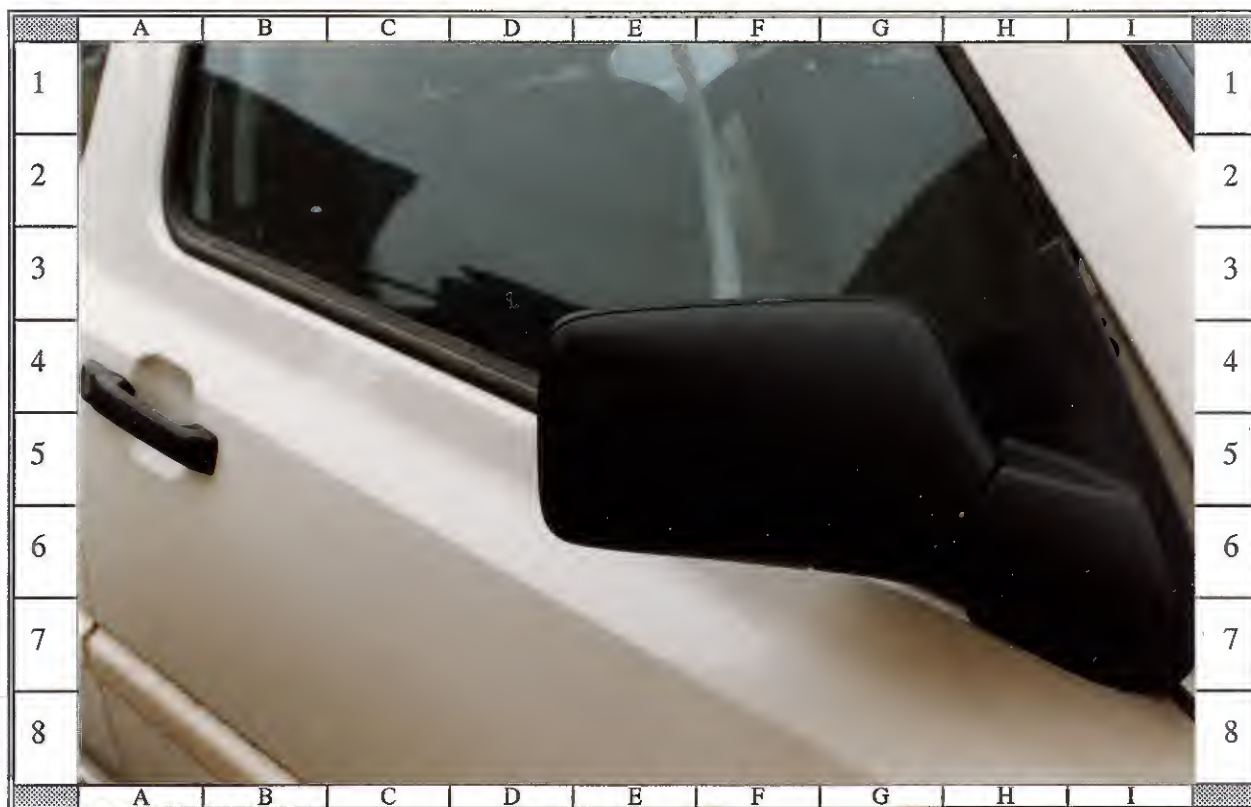
# 20: Close-up view of direct contact damage to Case Vehicle's right outside rearview mirror; NOTE: poor photo quality hides contact evidence

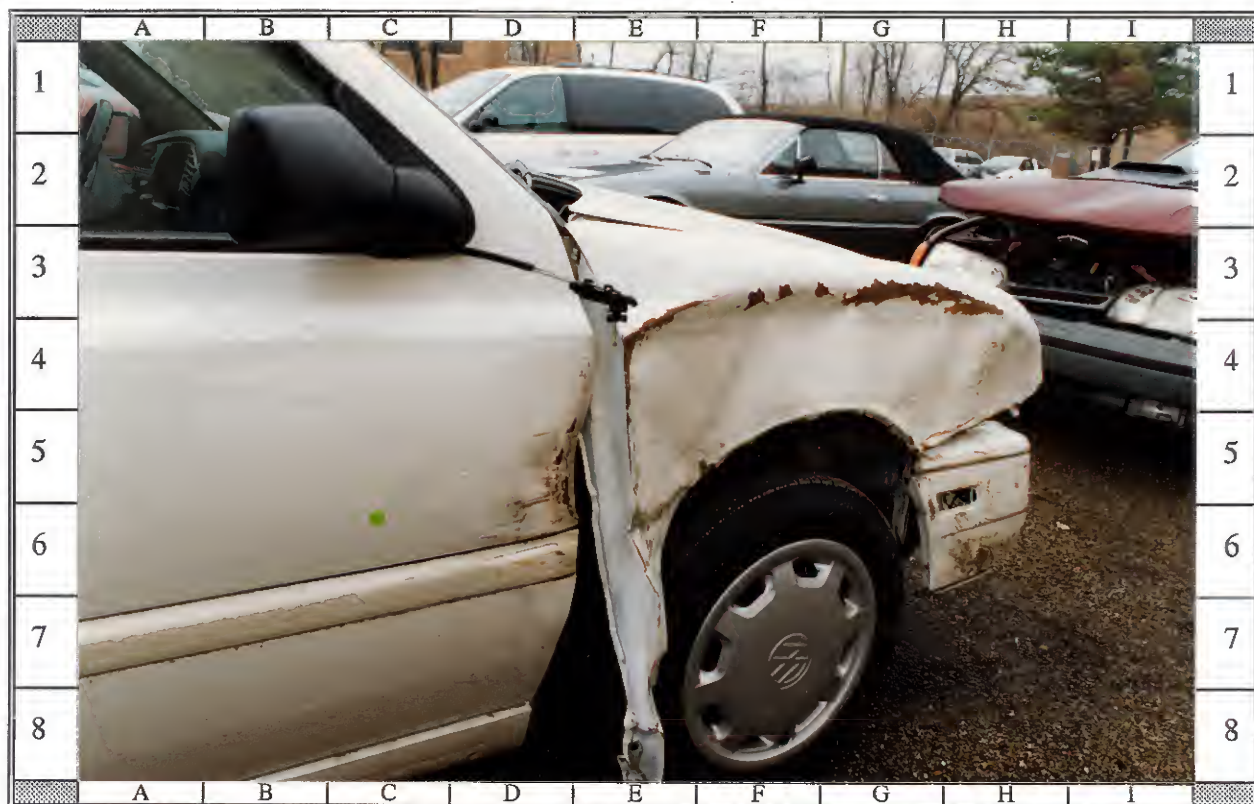
# 21: Case Vehicle's damaged right front fender viewed from approximately 45 degrees to right of back; NOTE: sideswipe type damage
